# Walkable Community Workshop

**Borough of Red Bank,  
Monmouth County**

# *Walkable Community Workshop Summary Borough of Red Bank, Monmouth County*

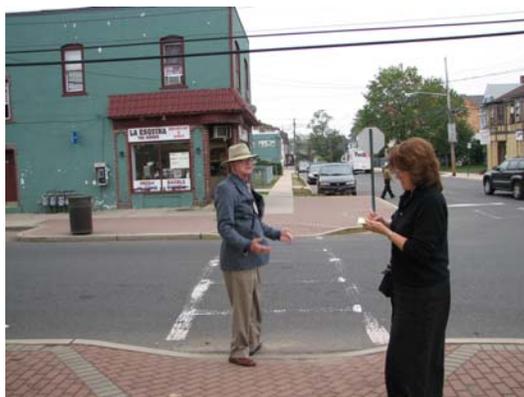
- Motor vehicles were perceived to be speeding on Bridge Avenue. The road is very wide considering it only has two travel lanes. On-street parking is provided, but not demarcated with paint. The wide open appearance of the street may be contributing to perceived speeding.
- Crosswalks need to be repainted and currently are not well-marked. This upgrade should occur immediately as this is a major pedestrian route to the transit station.
- Street signs are mounted too low. Some are less than 7 ft above the street.

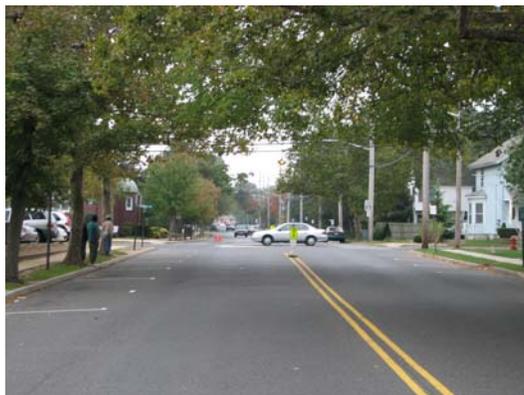
- Shrewsbury Avenue widens considerably to the south of West Front Street (in front of the senior center). The width of the street, its flat grade, and lack of signalized intersections may be contributing to the perceived high vehicle speeds through the corridor. These conditions create a considerable risk for those using the uncontrolled crosswalks near the senior center. One workshop participant noted that it can take as long as 10 minutes to cross the street at peak period.

- A portable in street pedestrian warning sign was located at the curb.
- The crosswalk in front of the senior center terminates in the center's driveway. This sets up potential conflicts with entering/exiting motor vehicles.

- Add a flashing yellow beacon to warn of uncontrolled crosswalk.
- Move in-street pedestrian warning sign back into the center of the road. It currently resides on the side of the road where it is not visible.
- The crosswalk in front of the senior center should be relocated so that it does not terminate in the driveway of the facility. This could be accomplished in several ways. One option discussed is to narrow the senior center's driveway, and extend the curb to meet the crosswalk.
- Where Shrewsbury Avenue widens (near the senior center) parking lanes should be striped with a continuous line to visually narrow the road.
